Technical Report CHL-98-22
July 1998

Three-Dimensional Breakwater Stability Tests at Vale de Cavaleiros, Cape Verde

by Ernest R. Smith, Jeffrey A. Melby

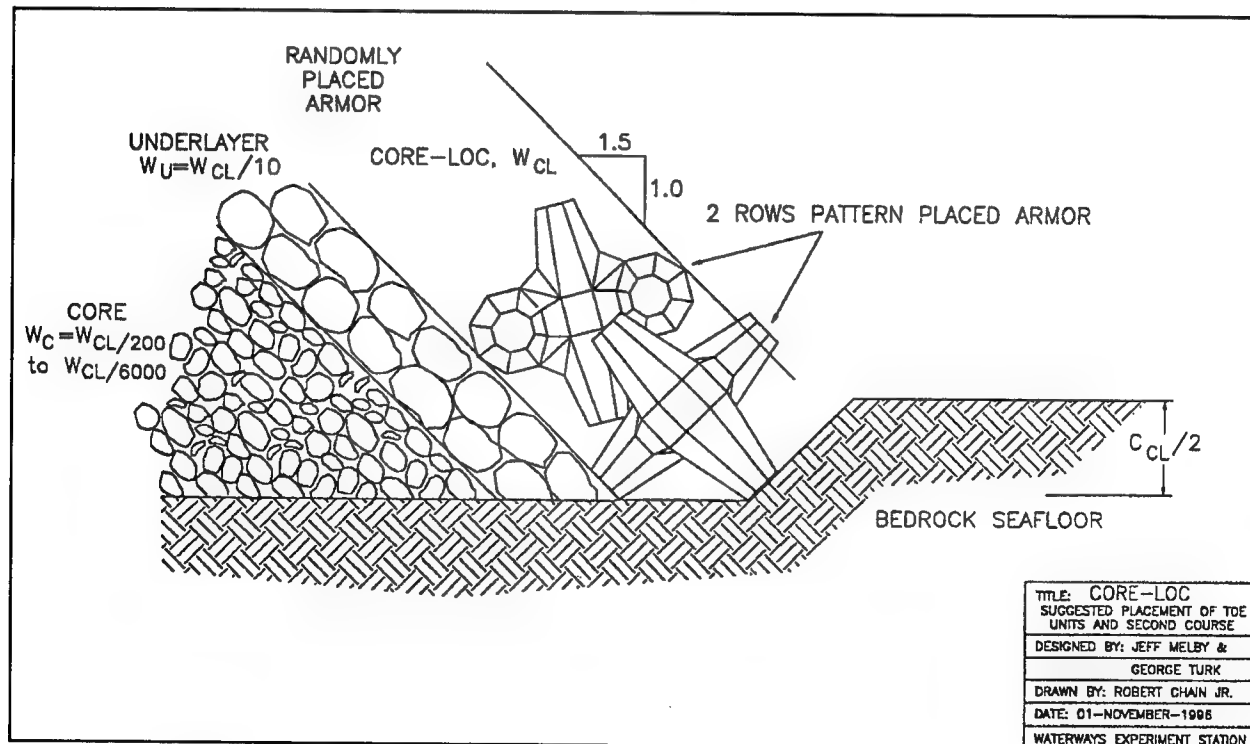
Figure 20. Example of toe trench constructed on rocky bottom

For the conditions tested in the model, the breakwater was not damaged if a stable toe trench, 1.5 m deep and near vertical, was installed. The model tests were conducted on a fixed bottom, which in nature would be analogous to a smooth rocky bottom in the prototype. An example of a prototype toe trench constructed in a rocky bottom is shown in Figure 20. The seaward face of the trench should be as near vertical as possible.

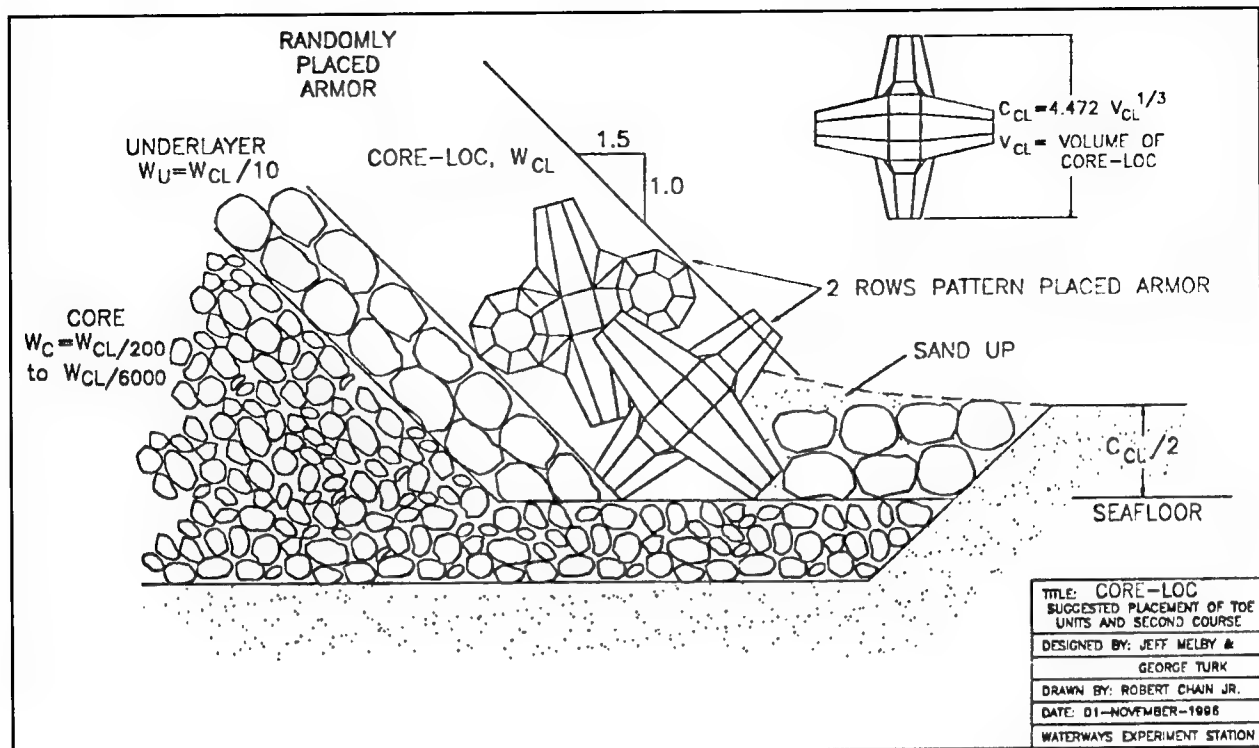
Figure 21. Example of toe trench constructed on sandy bottom

No model tests were conducted on stability with a movable bed; therefore, it was not possible to quantify the effects of a sandy bottom on the stability of the toe trench because the model floor was fixed. For structures placed in shallow water the *Shore Protection Manual* (1984) recommends a toe protection scheme similar to Figure 21, in which a wide trench is constructed and replaced with armor. The *Shore Protection Manual* suggests constructing the trench horizontally 2 times the water depth or 2 to 3 times the design wave height for the most severe scour.

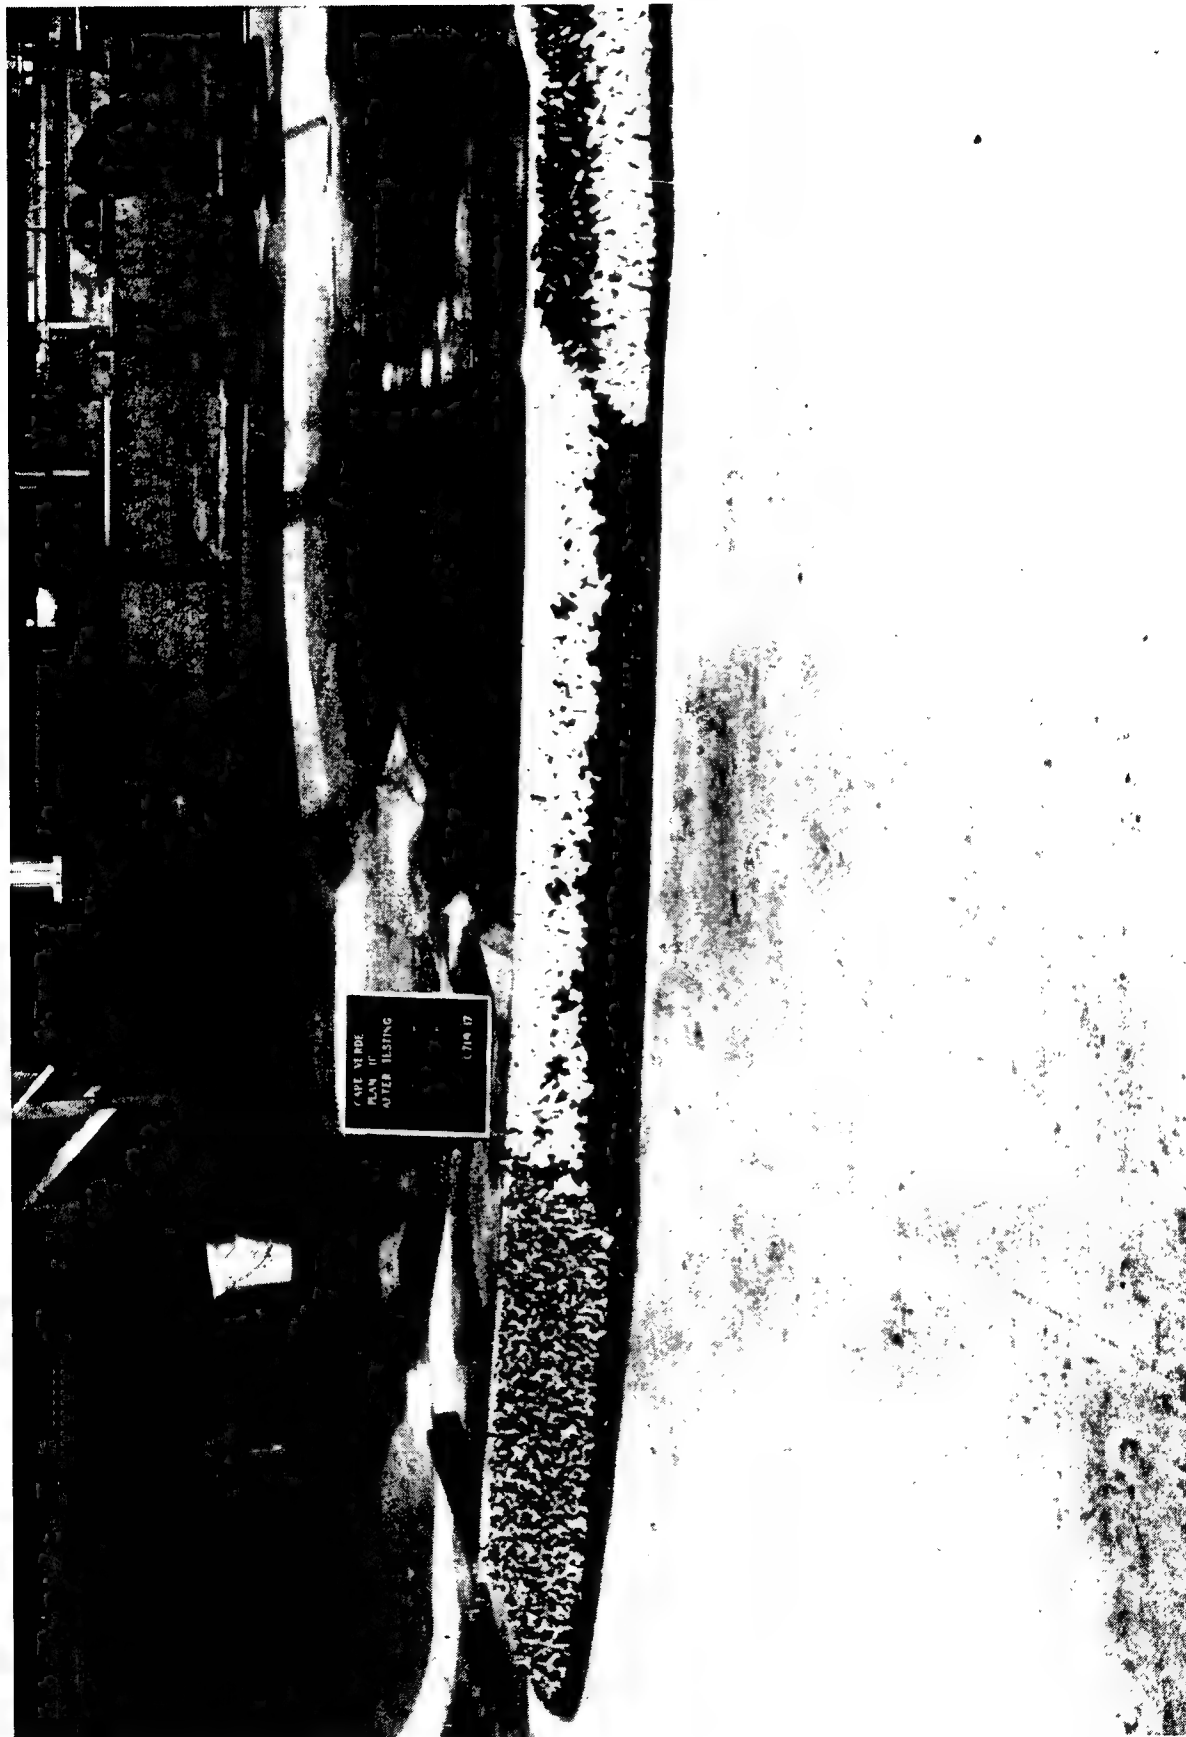
Photo A17. Sea-side view of plan 1C after testing with 19-sec, 6.7-m waves

11-tonne and three 8-tonne toe units were displaced. The toe failed near Profile 10 during 19-sec, 6.7-m waves at a location where the chain was forced seaward between anchors (Photos A17 through A19).

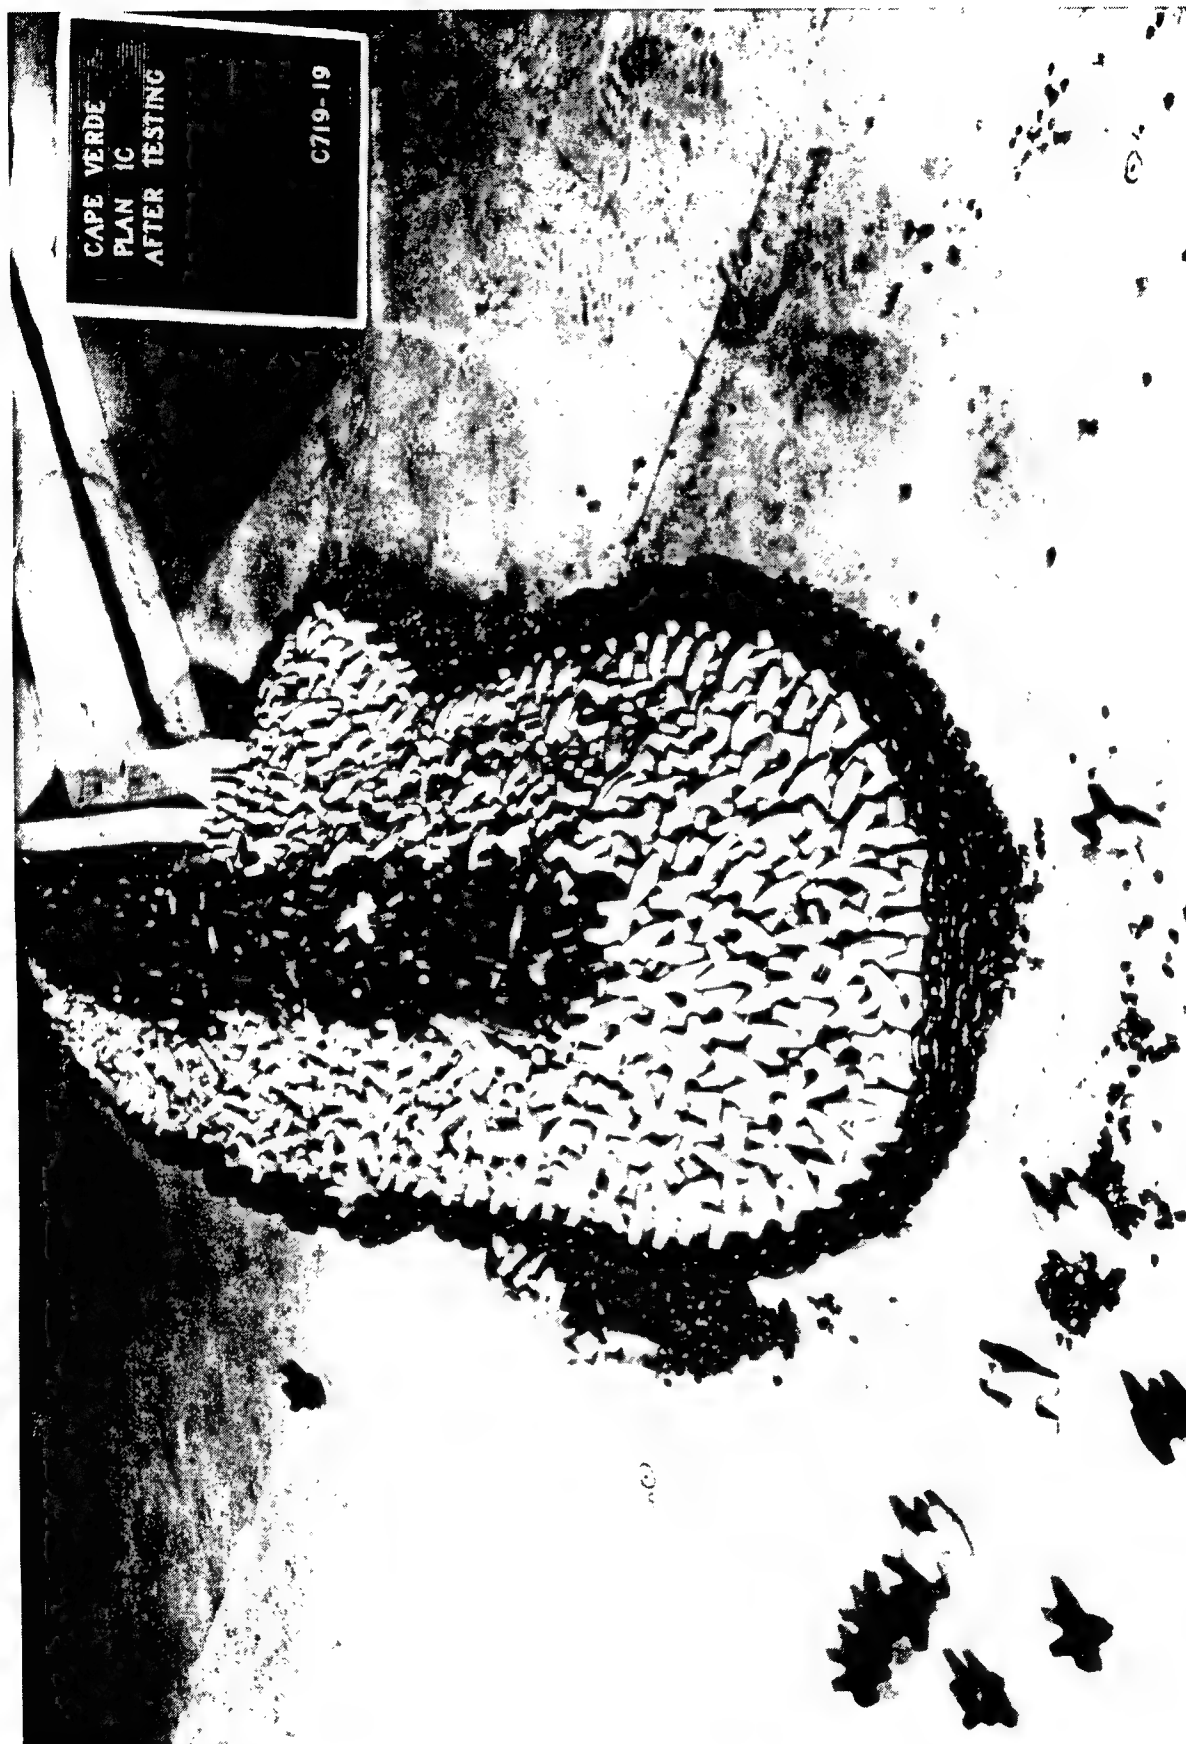
Photo A19. View of plan 1C breakwater head after testing with 19-sec, 6.7-m waves

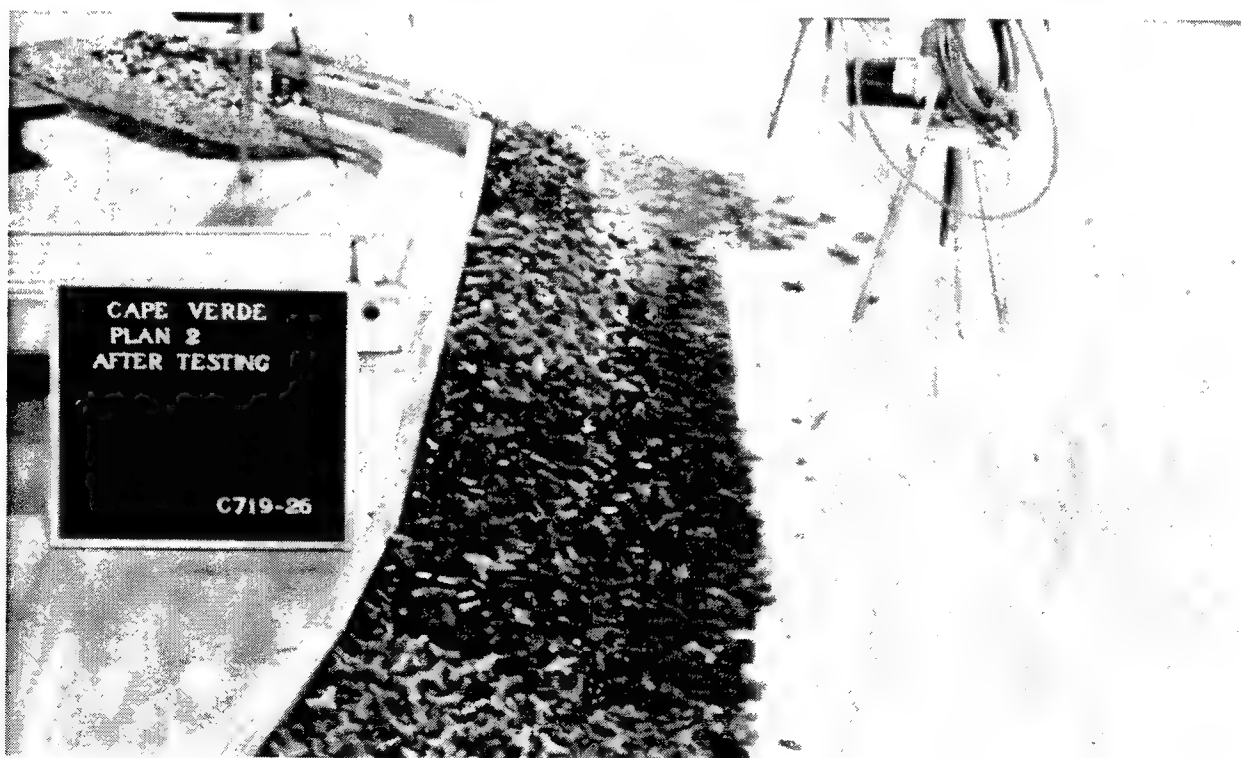
Photo A26. View from north of plan 2 breakwater trunk after testing with 13- and 16-sec, 3.7-m waves

Based on observations of the model and conversations with JV RRI-BCEOM personnel Messrs. A. Merrien and L. Fischer, Plan 2 consisted of raising the +5-m head portion of the breakwater to bring the entire structure to +8 m to reduce overtopping. The 8-tonne units were replaced with 11-tonne Core-Locs and the toe was reinforced with additional 11-tonne units placed in a single row (Figure 13). The packing density of the 11-tonne Core-Locs was 0.62. Toe protection units were placed 90 deg to the toe units of the structure in a manner in which adjacent units interlocked (Photos A23 through A25). The 11-tonne Core-Locs used for toe protection were displaced during 13- and 16-sec, 3.7-m waves, and the armor layer failed due to toe instability (Photos A26 and A27).

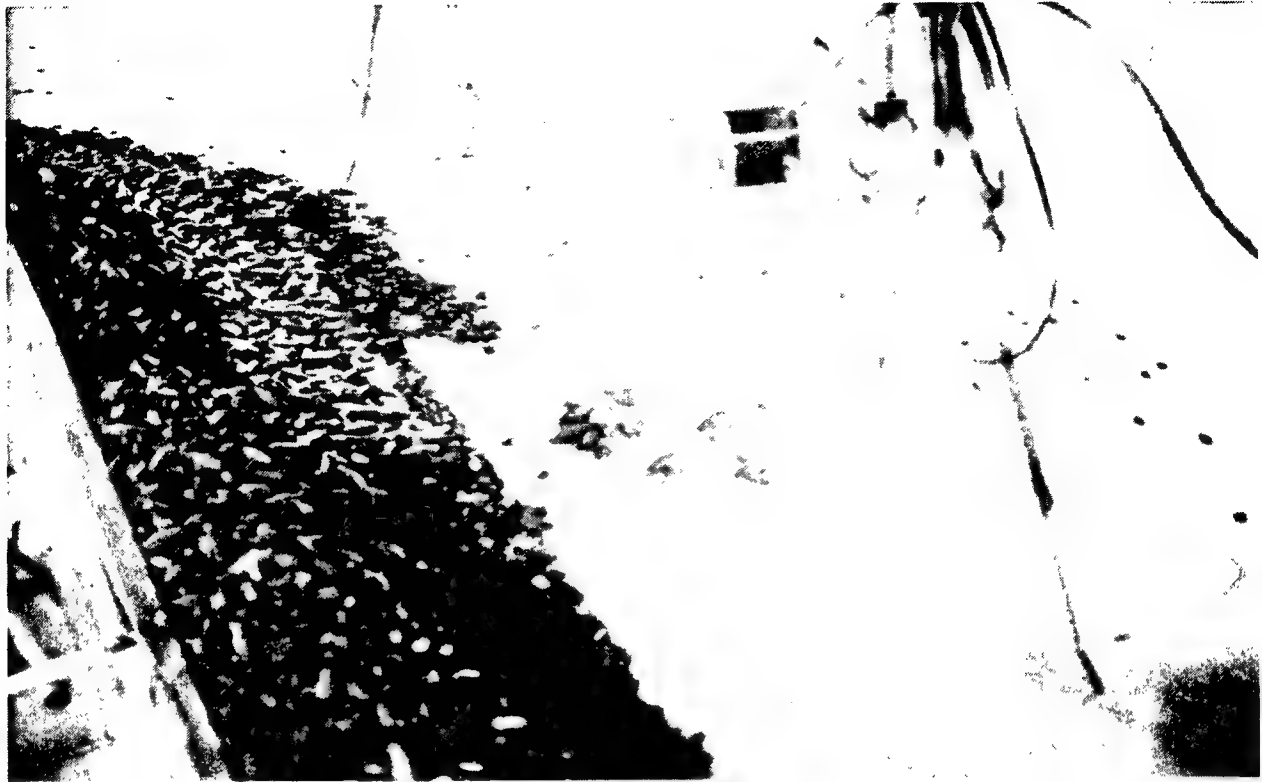
Photo A27. View of plan 2 breakwater trunk, profiles 6 to 8, after testing with 15-sec and 16-sec waves

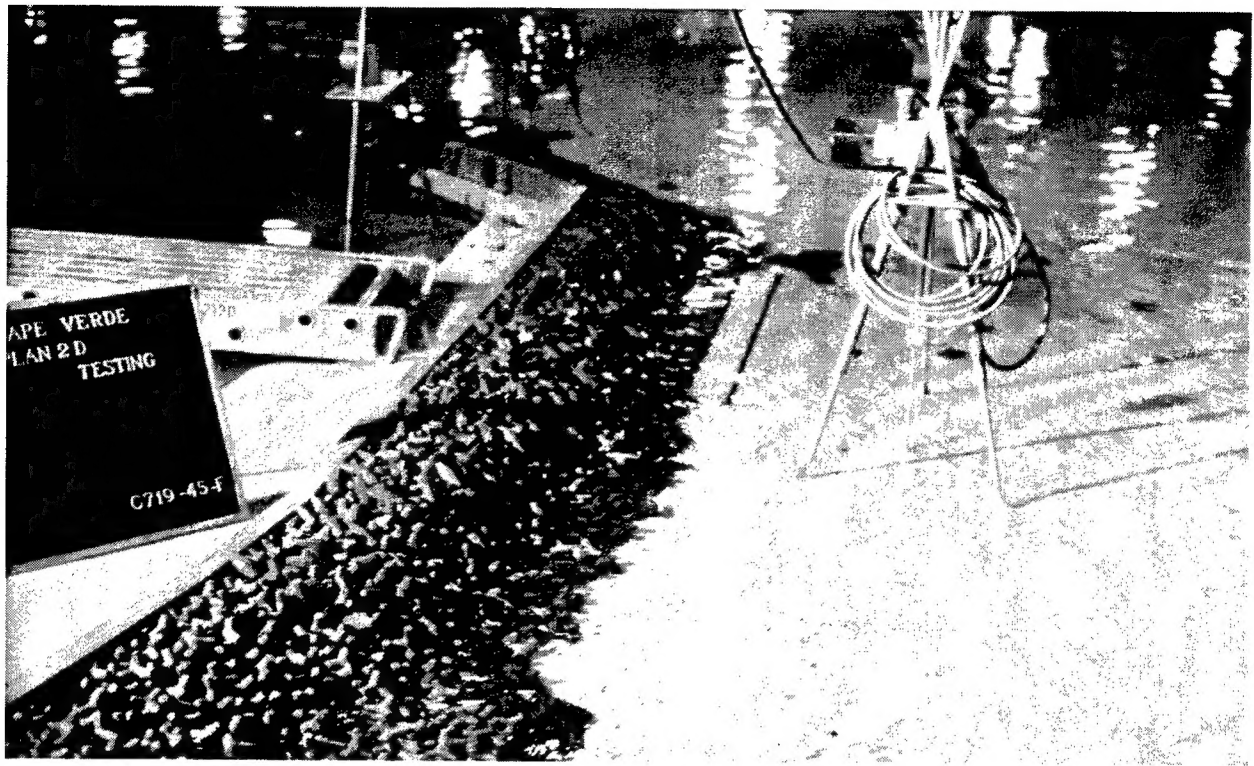
Photo A45. View from north of plan 2D breakwater trunk after testing with total sequence

units settled causing exposure of underlayer stone between Profiles 4 and 5 (Photos A45 and A46).

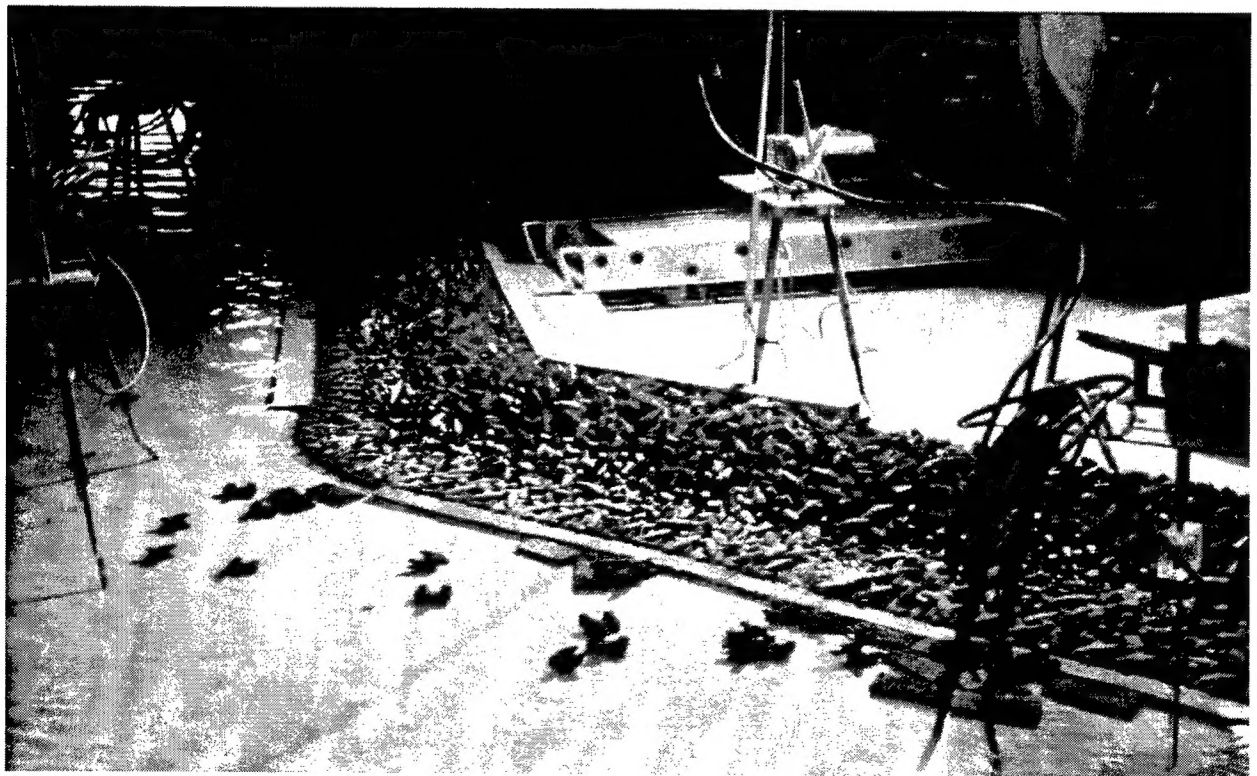
Photo A46. Sea-side view of plan 2D breakwater head after testing with total storm sequence
